Chapter 10 Case Studies of an Independent Consultant

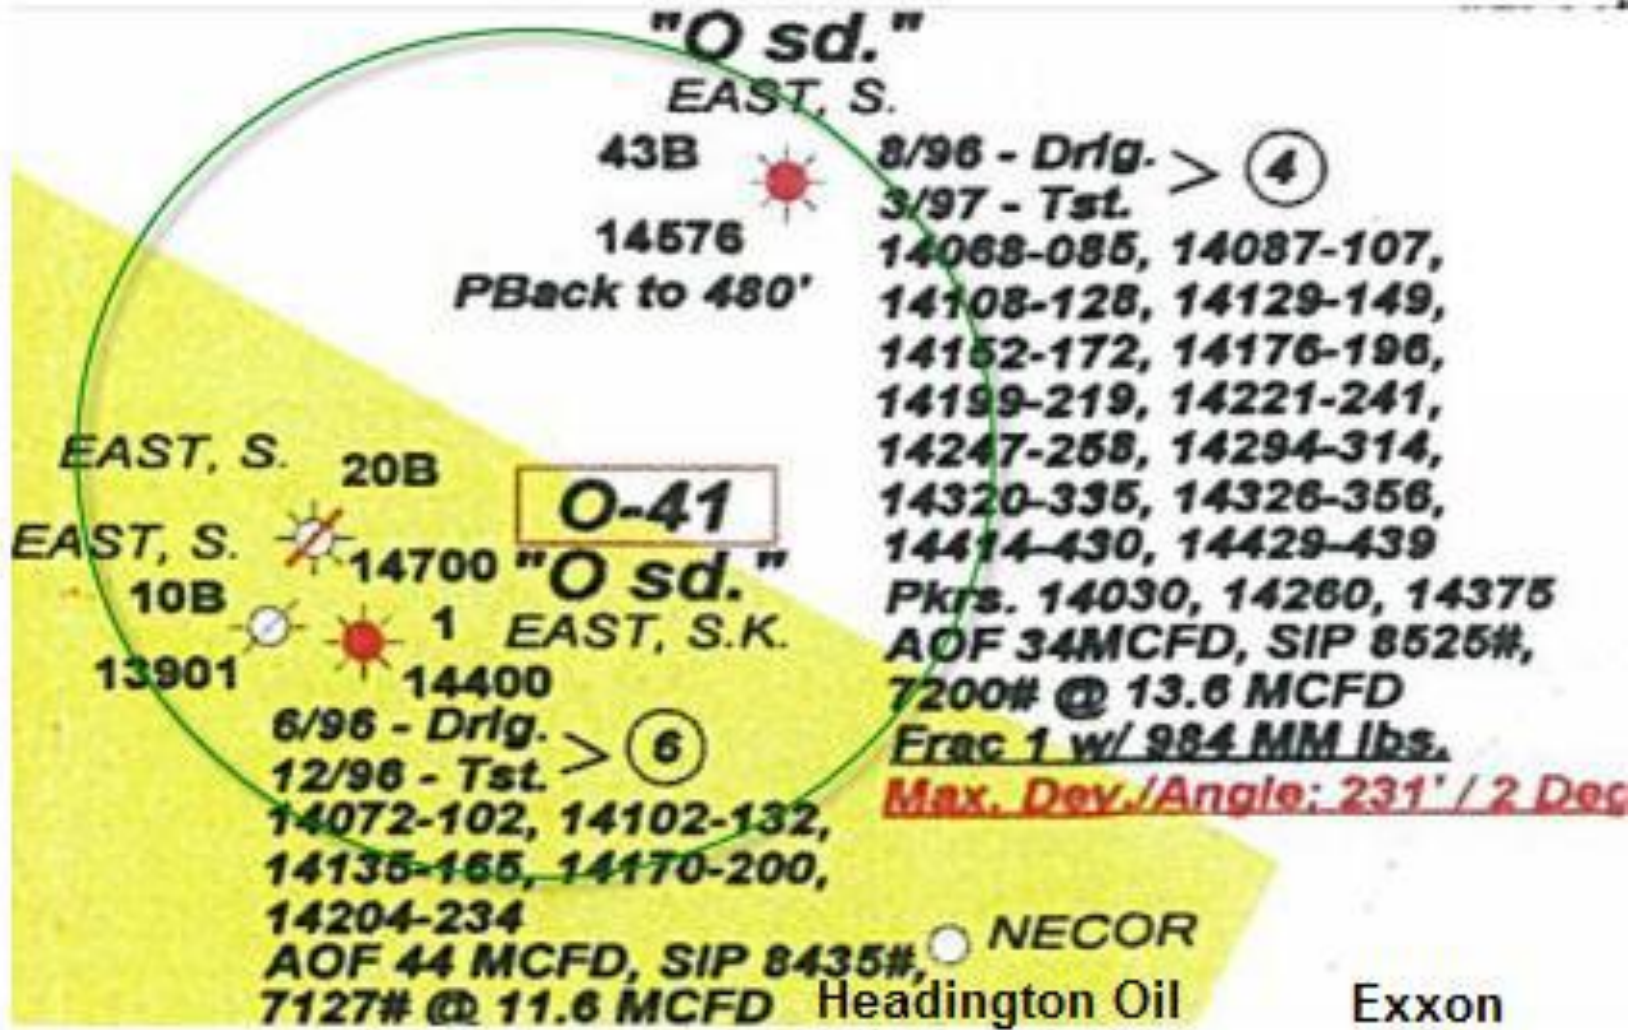
Drilling location Hedington East # 1 200 ft Offset to Mrs. S K. East B-20

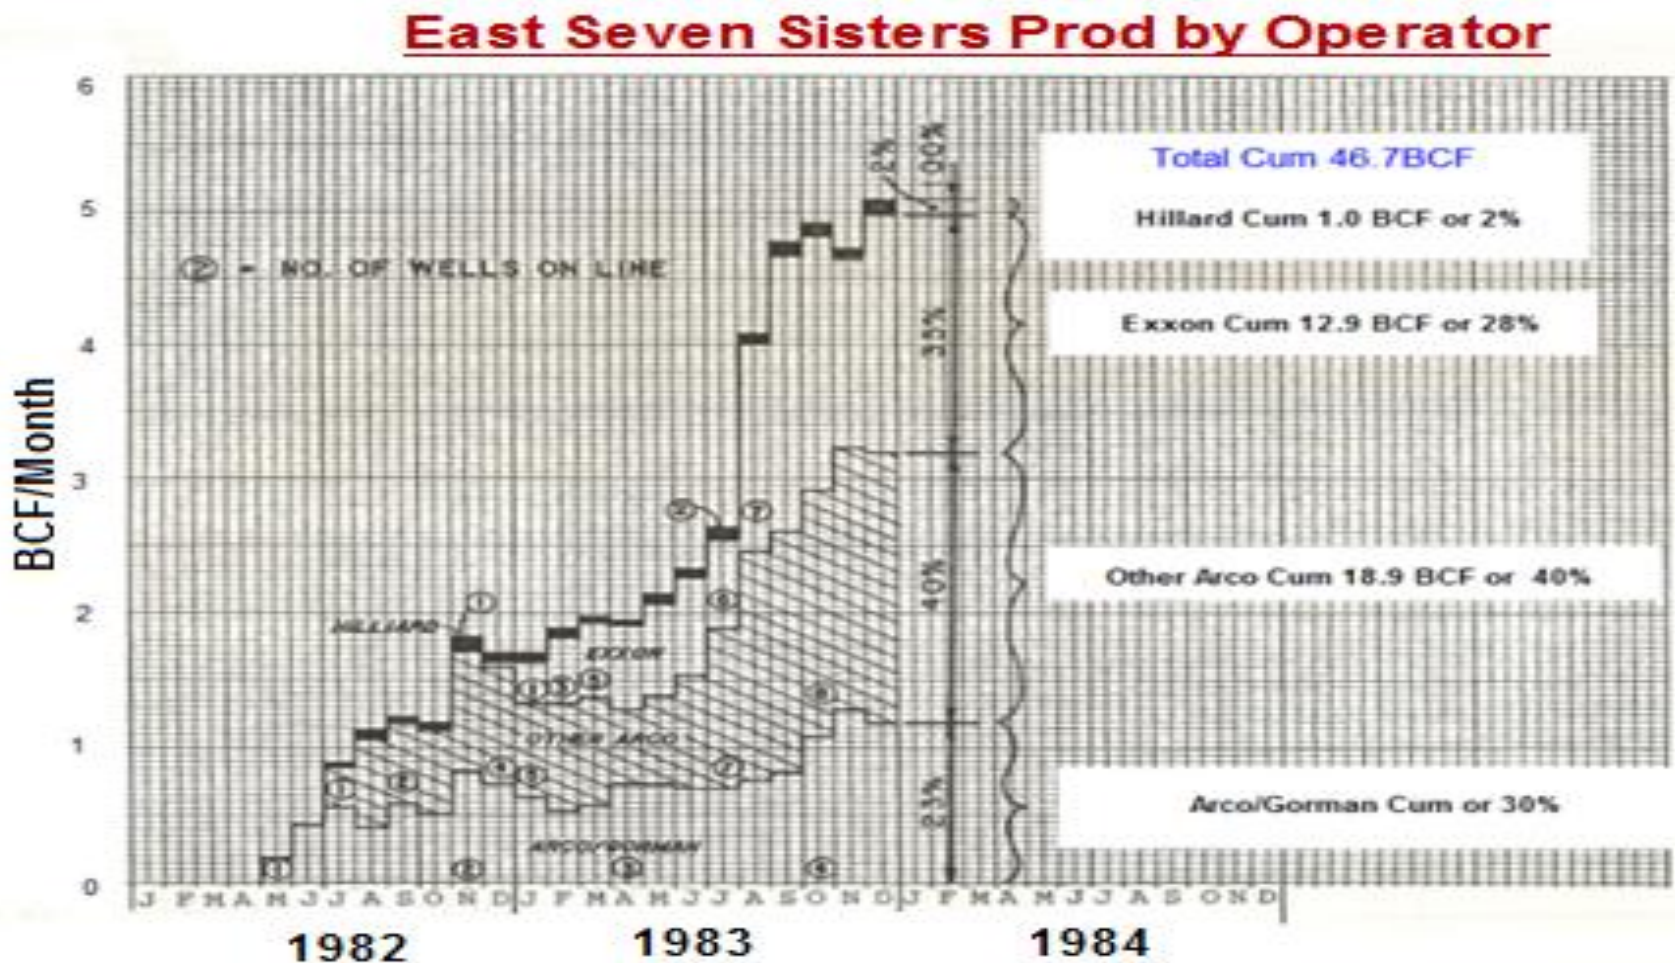
Fig. 10-25 Production build-up for the East Seven Sisters field, Duval County, Texas
